Engineering Failure Analysis 13 (2006) 1397-1409

Property and microstructure evaluation as a function of processing parameters: Large HY-80 steel casting for a US Navy submarine

John E. Holthaus, Michelle G. Koul, Angela L. Moran *

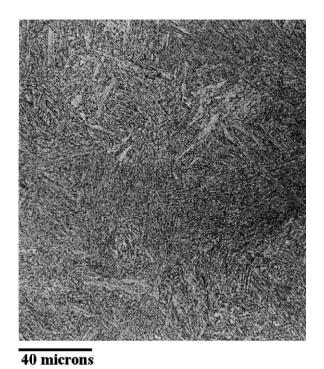
Fig. 1. Tempered martensitic microstructure found in a properly heat-treated HY-80 casting [4].

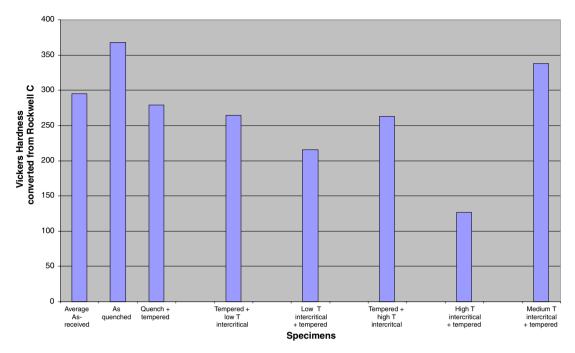
The "as-quenched" heat treatment was selected to obtain a microstructure with the highest hardness (and lowest toughness) expected, due to the anticipated 100% untempered martensitic structure. Results in Fig. 3 indicate high hardness values typical of this microstructure.

Fig. 3. Macrohardness of heat-treated HY-80 sections compared to average as-received hardness. All specimens were austenitized and quenched prior to the heat treatments listed with the exception of the as-received condition.

It appears that the IC heat treatment for the high and low IC cases did not drastically affect the hardness as compared to the desired quenched and tempered microstructure. In the case where tempering occurred first, it appears that the untempered martensite from the IC structure was not sufficient to elevate the hardness, or that the presence of low hardness ferrite compromised the overall hardness value. In the case where tempering followed the IC structure, the reduced hardness supports the idea that the presence of low hardness ferrite and the absence of untempered martensite (i.e., the martensite that is present is now tempered) reduces the hardness significantly compared to the desired quenched and tempered microstructure. Again, the temperature dependency of the hardness trends indicates that the phase reactions did not go to equilibrium.

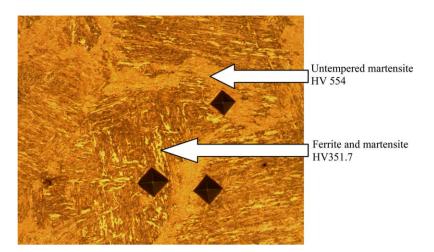
In the as-received material, two distinct microstructural regions are noted as shown in Fig. 4a. The first region consists of untempered martensite with high hardness and a grey, "hazy" appearance. The second region consists of a layered structure of martensite and ferrite. Untempered martensite was confirmed by its high hardness (HV 554) and also from comparison to earlier micrographs of untempered martensite. The layered structure contained various amounts of ferrite (a low hardness phase) and had a lower hardness in regions where this phase was more prevalent (HV 351.7). This microstructure is similar to the microstructure observed in the region of the original crack [5].

Fig. 4a. Optical micrograph of as-received HY-80 casting material, Nital etch, 200× magnification.

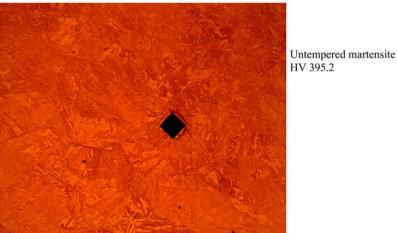
The austenitized and quenched specimen had an evenly distributed untempered martensite phase as seen in Fig. 4b. This hardness value (HV 395.2) is consistent with steel of 0.2% carbon content [4].

Fig. 4b. Optical micrograph of as-quenched HY-80 casting material, Nital etch, 200× magnification.

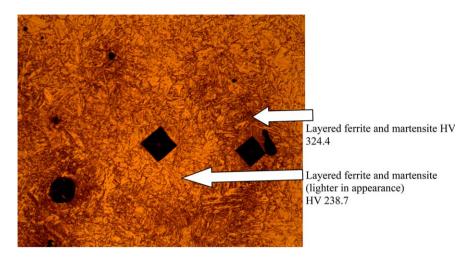
All of the remaining specimens were austenitized, quenched and then exposed to various combinations of IC heat treatments. The tempered + low IC specimen showed a fairly uniform ferrite (white) and martensite (dark) microstructure arranged in layers as seen in Fig. 5a. The fineness of the layered structure prohibits the measurement of the hardness of the individual phases. However, it is believed that the low hardness ferrite layers average with the high hardness expected for the untempered martensite layers, resulting in low-to-reasonable microhardness values. Higher magnification focused on the ferrite-dominated region (Fig. 5b), shows the lighter color of the ferrite layered with the martensite. The measured hardness values were lower in this region where there was more ferrite phase (239 HV). Similarly, the higher magnification of the martensite reasonable measured hardness (324 HV).

Fig. 5a. Optical micrograph of tempered + low IC HY-80 casting material, Nital etch, 200× magnification. (For interpretation of the references to colour in this figure legend, the reader is referred to the web version of this article.)

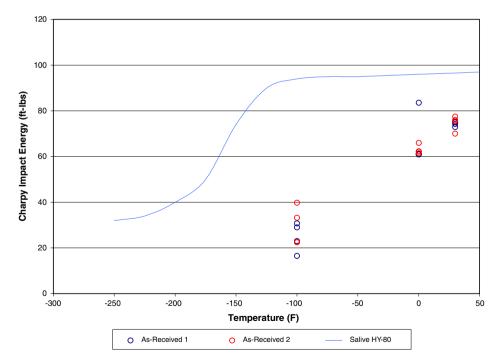
Charpy V-notch specimens were machined from the as-received and heat-treated specimens according to ASTM specifications [8]. The as-received material was tested at $-100 \,^{\circ}\text{F} (-73 \,^{\circ}\text{C})$, $0 \,^{\circ}\text{F} (-18 \,^{\circ}\text{C})$ and $30 \,^{\circ}\text{F} (-1 \,^{\circ}\text{C})$. Fig. 6 compares the Charpy impact energies obtained in this study with properly processed HY-80 material [9]. The ductile to brittle transition range for HY-80 is designed to be well below service temperatures, but data indicates that the as-received material from the failed casting had a transition between 15 $^{\circ}\text{F} (-9 \,^{\circ}\text{C})$ and $-75 \,^{\circ}\text{F} (-59 \,^{\circ}\text{C})$. Therefore, the material from the failed casting exhibits brittle behavior at higher temperatures than is desired.

Fig. 6. Charpy impact energy as a function of test temperature for as received HY-80 casting material as compared to properly processed HY-80 [9].

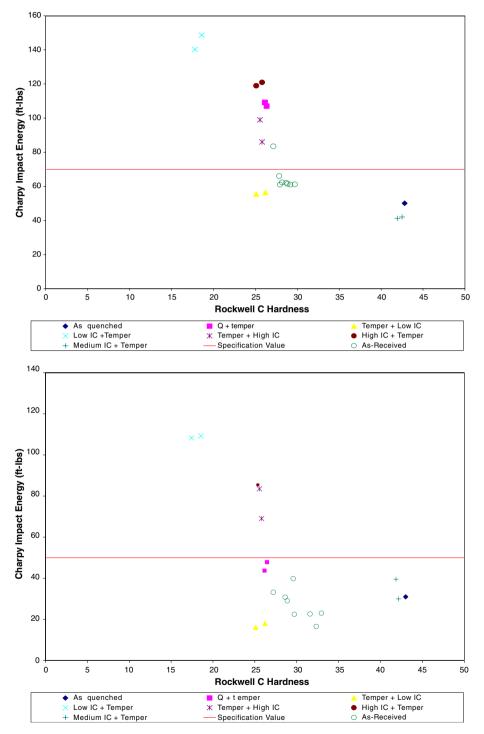
Fig. 7. Charpy impact energy (CVN) as a function of average Rockwell C hardness for a test temperature of (a) 0° F and (b) -100° F. Red lines indicate minimum acceptable toughness as given by military specifications. (For interpretation of the references to colour in this figure legend, the reader is referred to the web version of this article.)

shown in Fig. 7a for testing at 0 °F (-18 °C) and in Fig. 7b for testing at -100 °F (-73 °C). As a reference, the minimum acceptable toughness values from MIL-S-23008C for each temperature are also shown: all those specimens below the red lines failed to meet specification values.

The as-quenched and the medium IC + tempered conditions had high hardness values. As expected, they failed to meet the toughness specifications at both temperatures (Fig. 7a and b).

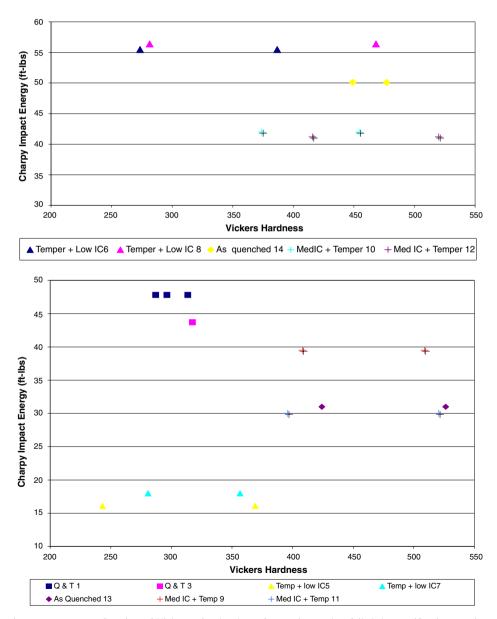
The remaining specimens all had macrohardness values that were in a similar range; consistent with values for properly processed HY-80 material. However, Fig. 8 shows that the as-received and tempered + IC conditions consistently resulted in material that did not meet specifications. These results indicate that although high hardness can be an indicator that there is a problem with HY-80 processing, it is possible to have poor toughness values for material with typical hardness values.

Fig. 8. Charpy impact energy as a function of Vickers microhardness for specimens that failed the specification requirements at (a) $0 \degree F$ (b) $-100 \degree F$.

Charpy impact specimens that failed to meet specification were sectioned to examine the microstructure directly associated with the deficient impact toughness values and microhardness results are shown in Fig. 8. Results show that each specimen that failed to meet specifications (with the exception of the asquenched and the quench and tempered) showed two microstructural regions with differing hardness values. In each case, there was a region of high hardness martensite, which likely results in the poor impact properties of the material condition and controls the fracture behavior.
